Stains - Identification and Prevention

Abstract: This *Technical Note* provides descriptions and photographs that aid in identifying efflorescence and stains on brickwork. It includes information on stain composition, factors that influence their occurrence, and stain prevention.

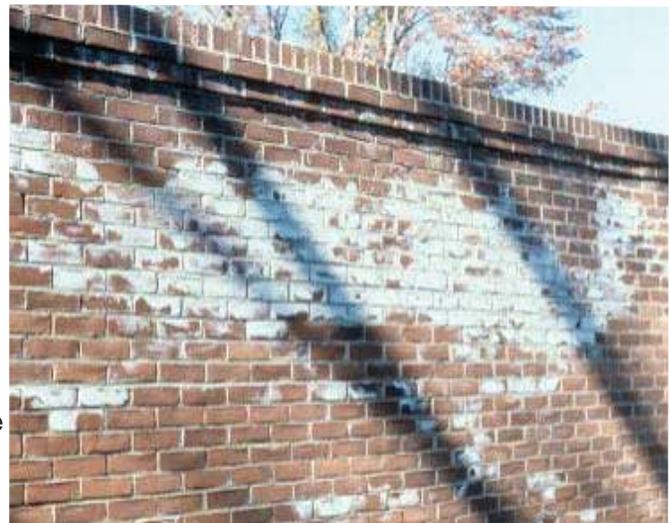
Efflorescence is normally a harmless deposit of water-soluble, white salt crystals, as shown in **Photo 1**. In some instances efflorescence may appear on mortar joints as shown in **Photo 2**. Efflorescence may appear in limited areas on the surface of brickwork as shown in **Photo 3** or, in extreme cases, cover the entire brickwork surface.

Photo 1
Efflorescence

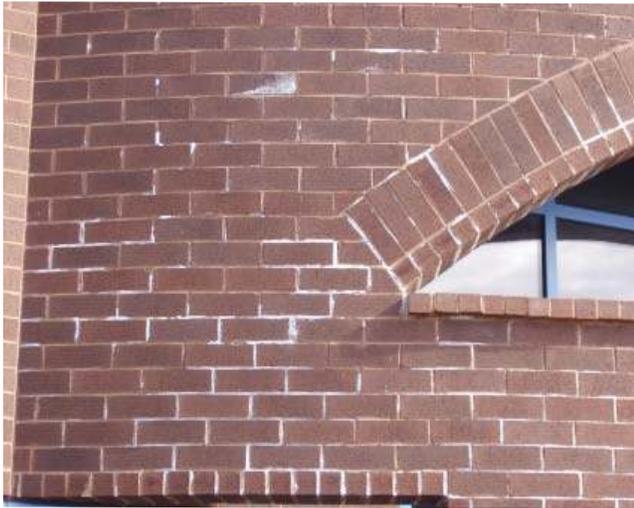
Photo 2
Efflorescence on Mortar Joints

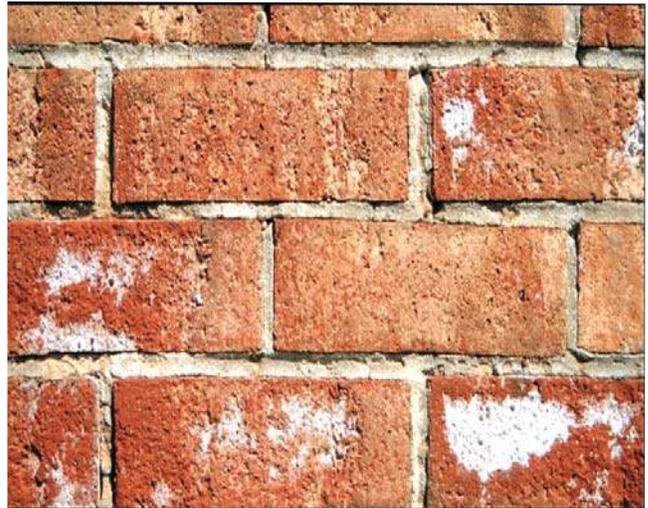
Photo 3
Efflorescence in Limited Areas

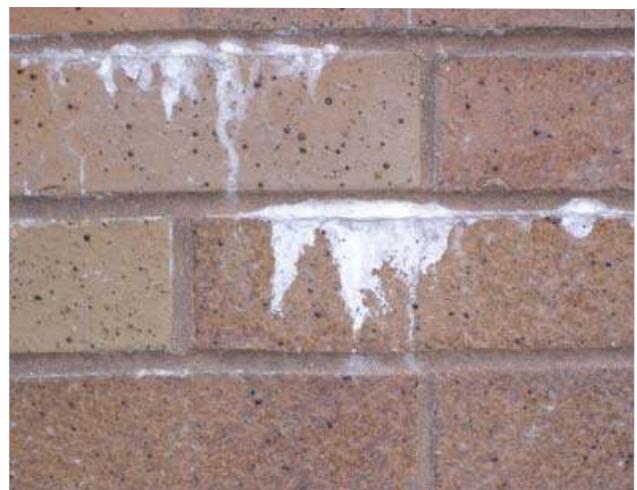
Calcium carbonate deposits, sometimes referred to as “lime run,” usually appear as white or gray, crusty formations originating from a spot and running down the face of the wall, as shown in [Photo 4](#). However, the term “lime run” is misleading since the stain is not a direct result of the lime component in the mortar. In fact, hydrated lime actually helps to reduce the risk of lime run. Lime run nearly always occurs at a small hole or opening or hairline crack in the face of the brick masonry, as shown in [Photo 5](#).

Photo 5
Lime Run

Materials containing cement are sources of calcium compounds and are an integral component of or may be in contact with the brickwork. To reduce the possibility of lime run, excess water must be eliminated or the path must be disrupted. Once lime run begins, it is likely to continue until difficult to the water source is stopped.

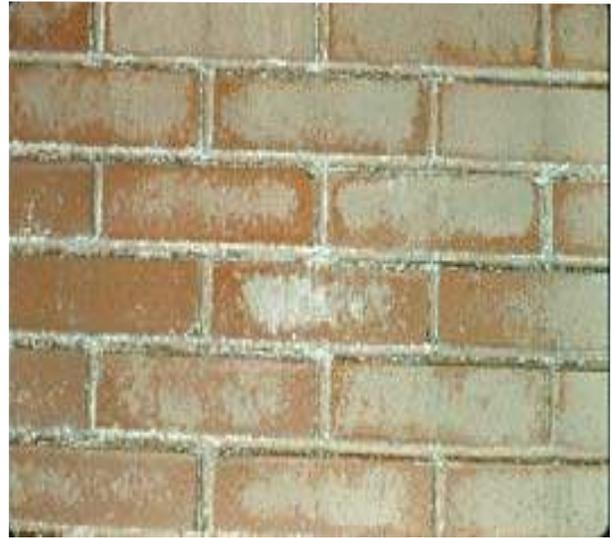
Silicate deposits, sometimes referred to as “white scum,” usually appear as white or gray discolorations on the face of brick masonry, as shown in [Photo 6](#). The discoloration may be present over the entire face of the brickwork or in smaller, irregularly shaped areas. White

A number of mechanisms may precipitate white scum on brickwork. White scum is typically related to the cleaning of brickwork with unbuffered hydrochloric (muriatic) acid solutions or inadequate pre-wetting or rinsing of the brickwork during cleaning.

Photo 6
White Scum

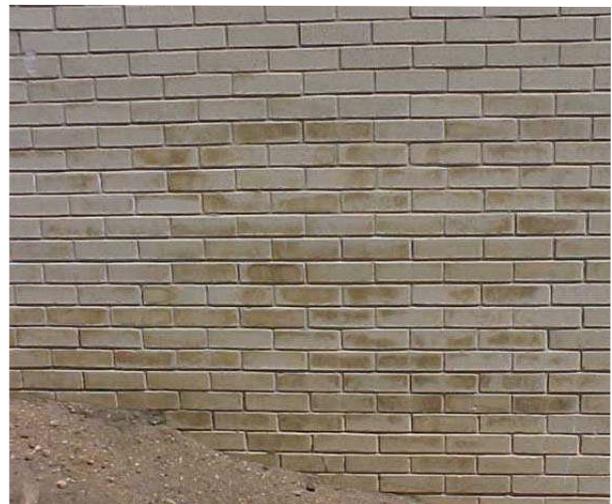
Some brick develop yellow or green salt deposits as shown in [Photos 7](#) (yellow) and [8](#) (green) when they come in contact with water or unbuffered hydrochloric (muriatic) acid. These stains are usually vanadium salts. They may be found on red, buff or white brick; however, they are more conspicuous on lighter-colored brick. The vanadium salts responsible for these stains originate in the raw materials used for the manufacture of the brick. The yellow and green stains are usually vanadyl salts, consisting of sulfates and chlorides, or hydrates of these salts.

Vanadium stains occur in a manner similar to efflorescence, except that vanadium oxide and sulfates are dissolved and result in a solution that may be quite acidic. As water evaporates from this solution at the surface of the brickwork, vanadyl salts are deposited. The chloride salts of vanadium, such as vanadyl chloride, may form as a result of washing with unbuffered hydrochloric (muriatic) acid or excessive moisture exposure. [Ref. 2]

Photo 7
Yellow Vanadium Stain

Preventing vanadium stains is important, since they can be difficult to remove and improper cleaning efforts may result in a brown, insoluble deposit. To minimize the potential for vanadium stains, the following steps are recommended:

- Store brick off the ground and under non-staining protective covers.
- Never use or permit the use of highly-concentrated, unbuffered hydrochloric (muriatic) acid solutions to clean light-colored brick.
- Seek and follow the cleaning recommendations of the brick manufacturer.

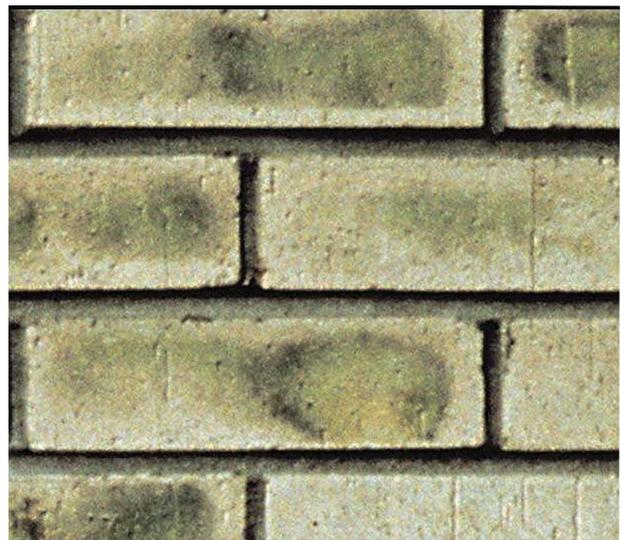
Photo 8
Green Vanadium Stain

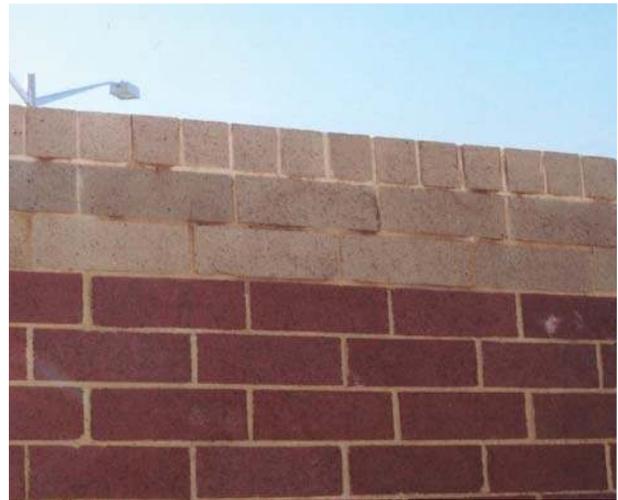
Under certain conditions, tan, brown, or occasionally gray staining may occur on the mortar joints of brickwork as shown in [Photo 9](#). Occasionally, a brown stain will streak down onto the faces of the brick as shown in [Photo 10](#). This type of stain is the result of having a manganese oxide as a coloring agent in tan, brown, black or gray brick and its reaction to an acid.

During the brick firing process, the manganese coloring agents undergo several chemical changes, resulting in manganese compounds that are insoluble in water. They have varying degrees of solubility in weak acids. Once dissolved, these compounds may migrate in solution toward the surface of brickwork. As previously discussed, acid solutions can occur in brickwork under certain conditions. Brick may also absorb unbuffered hydrochloric (muriatic) acid during cleaning. It is also possible that some geographical areas may be subject to acid rain. [Ref. 4]

Manganese staining is closely related to efflorescence, since it is the sulfate and chloride salts of manganese that travel to the surface of the brickwork. When the solution reaches the mortar joints, the salts are neutralized by the cement or lime in the mortar producing insoluble manganese hydroxide. The manganese hydroxide precipitate is deposited on the mortar joint and when dry converts to brown manganese tetroxide resulting in the stain. [Ref. 2]

Photo 9
Manganese Stain

Unbuffered hydrochloric (muriatic) acid should not be used to clean tan, brown, black or gray brick. Proprietary cleaning compounds are available for cleaning brick containing manganese. Test for effectiveness and follow the advice of the brick manufacturer.

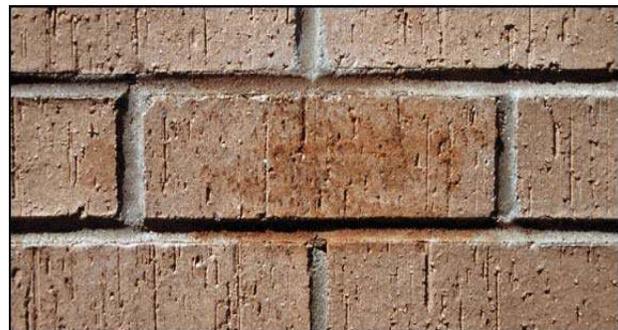
Photo 10
Manganese Stain

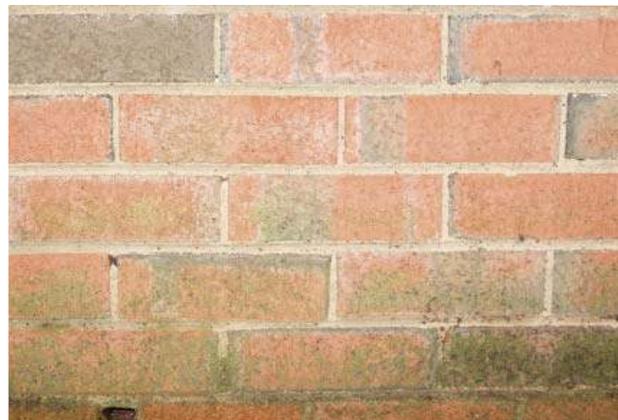
Other stains affecting brickwork are generally caused by external sources such as pollution, organic growth, runoff or others. Usually, the source or composition of these stains is obvious. Organic stains, as shown in [Photo 11](#), can include algae, mold, or other organisms. Certain materials above or adjacent to brickwork such as copper ([Photo 12](#)), bronze, aluminum, synthetic stucco or paint ([Photo 13](#)) can stain brickwork surfaces. In addition, externally caused stains such as hard water from sprinkler systems can effect brickwork ([Photo 14](#)). The color and appearance should be considered during identification. Laboratory or field tests can determine the stain composition and assist in proper identification. Once the correct identification is made, the appropriate method to clean the brickwork can be implemented.

Photo 11
Organic Stain

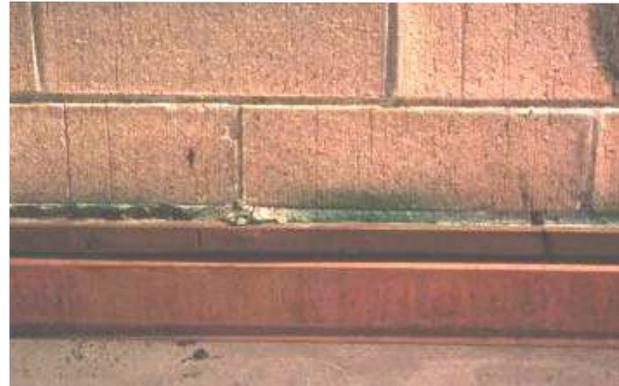
Photo 12
Stain from Copper

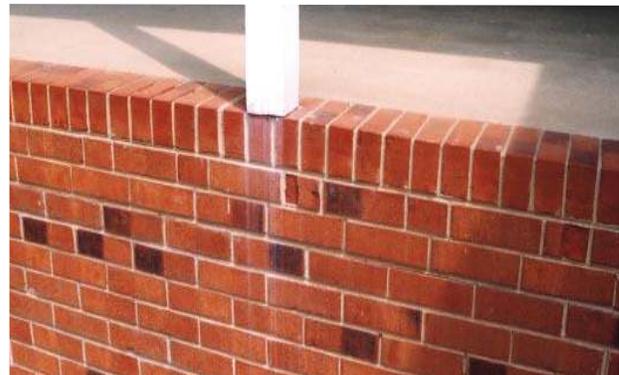
Photo 13
Runoff Stain from Paint

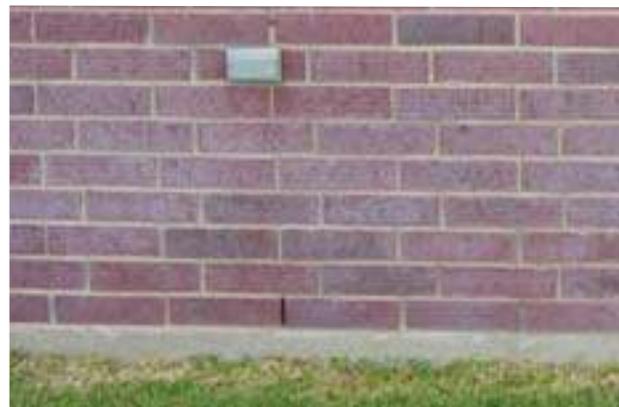
Photo 14
Hard Water Stain

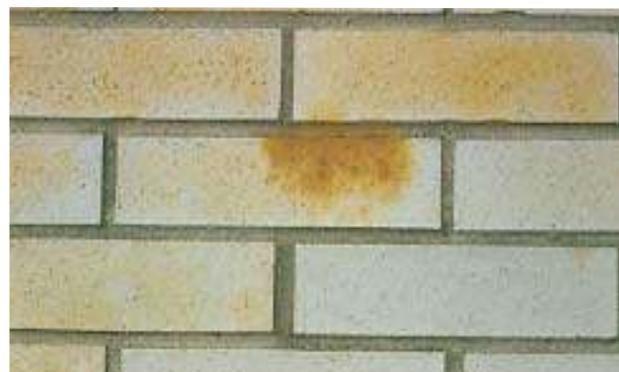
Rust-colored stains may actually be corrosion, as shown in [Photo 15](#). Such stains can be the result of

corrosion of wall ties or joint reinforcement in or adjacent to the brickwork. The use of improper mortar additives or ingredients, placement of wall ties or joint reinforcement with inadequate cover, welding splatter on the brick, or the corrosion of a material placed on the brick cube or pile prior to being laid in the brickwork can all attribute to these stains.

Photo 15
Rust Stain
